# Otter Tail River bank stabilization preserves farmland, pleases paddlers

## September Snapshots 2017

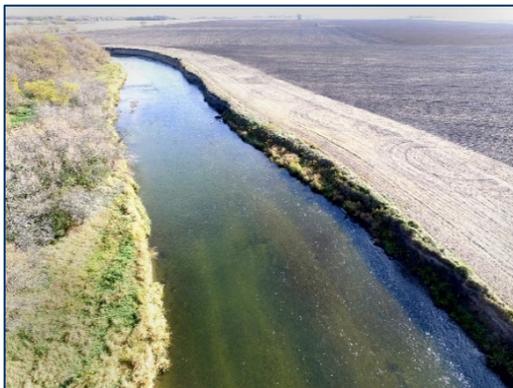
*From left: Day 1 of a streambank restoration project on the Otter Tail River in Wilkin County shows, at right, the field that was eroding into the river. A \$135,000 Clean Water Fund grant restored a 1,200-foot stretch of the bank. Heavy equipment was at work on Day 9. . Photo Credits: Wilkin SWCD*

A \$135,000 Clean Water Fund grant the Minnesota Board of Water and Soil Resources awarded in 2016 aims to restore and protect 1,200 feet of streambank along that bend in the Otter Tail River. BWSR calculates improvements – including a graduated, grassed slope on land and strategically placed tree trunks and roots in the water – will keep 440 tons of sediment out of the river annually.

The SWCD partnered with the Buffalo-Red River Watershed District and the project engineer to create a floodplain and curb the water’s energy by installing woody toe debris benches in the eroded bank. Tree trunks’ exposed roots faced the stream channel.

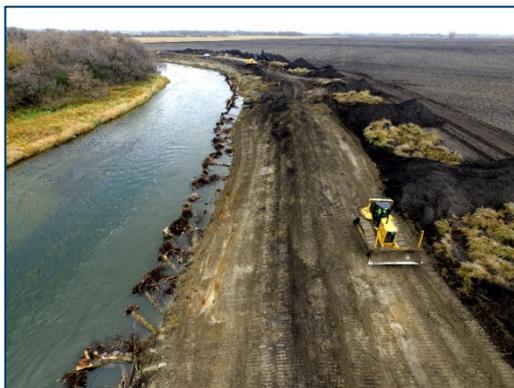
*From left: The aerial view on Day 13 showed woody toe debris benches, with exposed tree roots facing the stream channel. "We did this particular application because it was going to be a lot less expensive than the traditional rock riprap," said Don Bajumpaa, Wilkin SWCD district manager. Grasses have grown up on the buffer since the final day of construction. **Photo Credits:** Wilkin SWCD*

Sod mats containing willows and other woody vegetation were placed on top of the benches, where they will stabilize soil. Grasses planted on the reshaped, more gradual slope will meet the willows and tie the project together. A widened buffer strip on top of the bank will control erosion.
