# Cedar River Watershed work advances

The most expensive of Cedar River Watershed District’s \$8.4 million CIP projects break ground this summer. The first of 25 priority sites finished last season near Austin. All are designed to improve water quality, reduce flooding and retain topsoil.

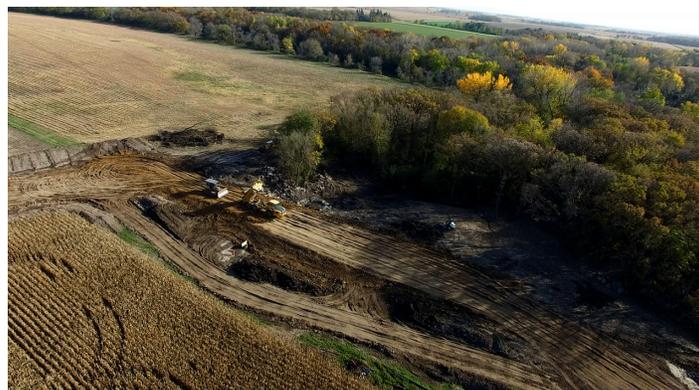
**Top:** Cody Fox, project manager for the Cedar River Watershed District, visits Dwane Hull’s property in September just outside Austin. The gully on is among 25 priority fixes. **Photo Credit:** Ann Wessel, BWSR  
**Above:** The view from a drone shows the berm under construction in fall 2017 on Hull’s property. **Photo Credit:** Cedar River Watershed District

At the edge of Hull’s field, which lies about 500 feet from the Cedar River, crews installed a new culvert and larger berm. The structure will detain runoff from the 400-acre drainage area for up to 24 hours, and then slowly meter it out. It’s built to withstand a 100-year flood.

“Our goal is slow (the runoff) down enough to allow sediment to drop out before it gets to the river, but also quickly enough to minimize risk to the crop field immediately adjacent to the structure,” said Cody Fox, CRWD project manager.

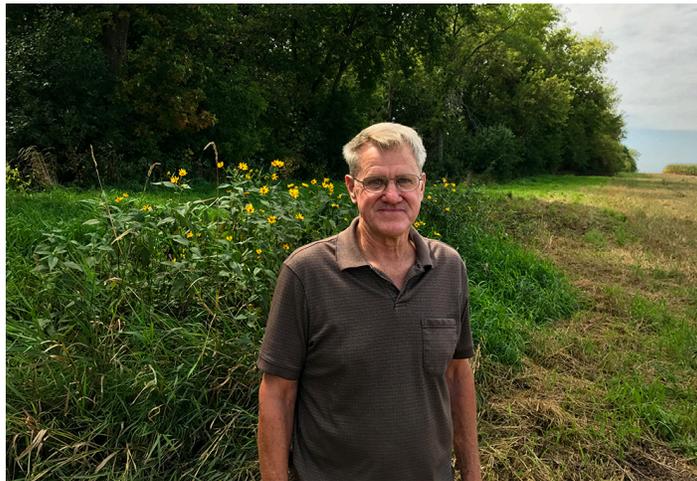
**Top:** Dwane Hull stood at the edge of his field where he’d replaced a culvert and berm years ago. The structure was on the verge of failing.

Hull built the berm in 2002 to fix an expanding gully. He replaced it two years later after a hard rain destroyed the berm and blew the

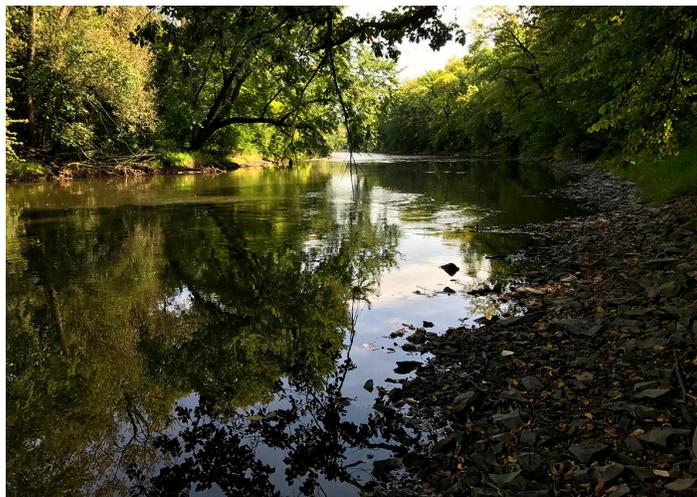
**Above:** Slabs of exposed bedrock edge the Cedar River at the bottom of a ravine. Recreational use has increased since the river became a State Water Trail in 2012. **Photo Credits:** Ann Wessel, BWSR

The culvert was replaced, the channel stabilized. Here, at the bottom of a deep ravine, slabs of exposed bedrock lay along the river.

“It’s down to the bedrock, which means it’s probably not going to get a whole lot deeper. But it also tells you: ‘Where did that soil go?’ It’s gone,” Fox said.
