# Restoring Shingle Creek

## August 2015 Snapshots

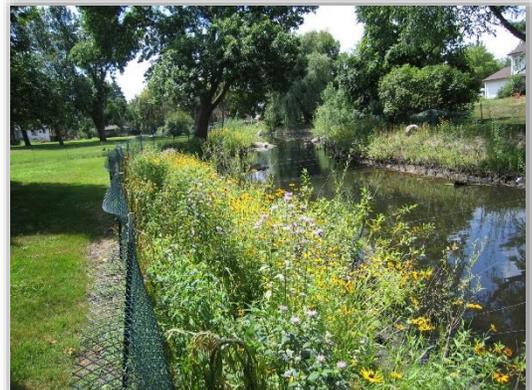
*Top: a photo of the 2005 restoration.  
Bottom: riffle as part of the 2011 restoration.  
Photos courtesy Diane Spector.*

In 2005 the City of Brooklyn Park started the process with help from the SCWMC. The partners completed a restoration project on 2,300 feet of Shingle Creek through a residential area in response to concerns from homeowners that erosion on the streambanks was cutting into their properties. They stabilized the banks using live stakes of willows and shrubs, removed a dam, and installed 32 rock vanes to address scouring in the channel.
