The waters of northeast Minnesota are one of the jewels in our state's crown. They are important natural resources, an economic driver, and a destination for tourists and sportspeople alike. Impaired watersheds are rare in this part of the state and the Knife River is one of them.

The problem in the Knife River is turbidity – cloudy water – caused by soil erosion along the river's banks. Since 2010, the Lake County Soil and Water Conservation District (SWCD) and its partners have successfully designed and implemented several projects aimed at reducing the Knife River's turbidity, multi-benefit work that will make a difference both for water quality and wildlife habitat.

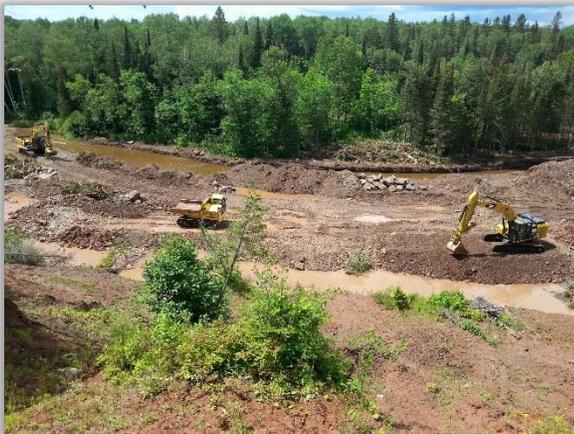
*Pictured, top: Construction of the new bank.  
Pictured, bottom: Floodplain bench installed at the  
bank stabilization site on the Knife River.*

The SWCD identified five banks on the river that were priorities for stabilization, and in 2012 received a \$221,000 Clean Water Fund (CWF) grant to stabilize the largest one. Flooding in the region delayed the project and work was finally completed during this last field season.

The stabilized bank is 1,200 feet long and 80 feet high, which is quite a footprint. It was designed to follow the natural channel and has drawn interest from other districts as a demonstration site for this type of approach to river restoration.
