# Rebuilt Cascade Creek mimics nature

In Rochester, Olmsted SWCD led a \$1.5 million stream reconstruction on 40 acres of a former golf course. The fix, 20 years in the making, provides water quality benefits, improved fish habitat and flood control measures.

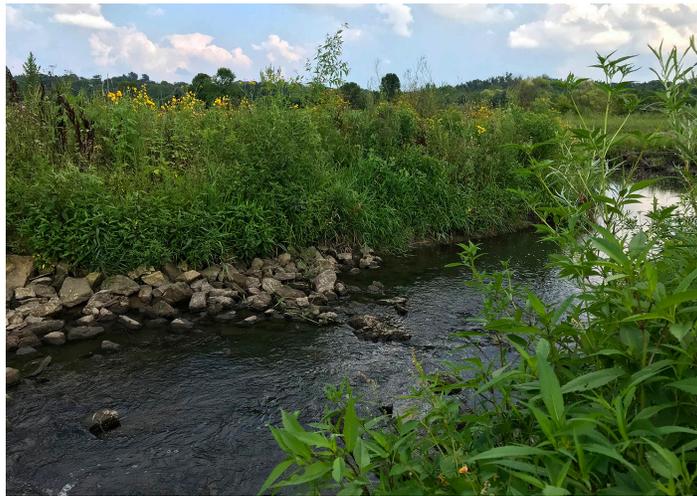
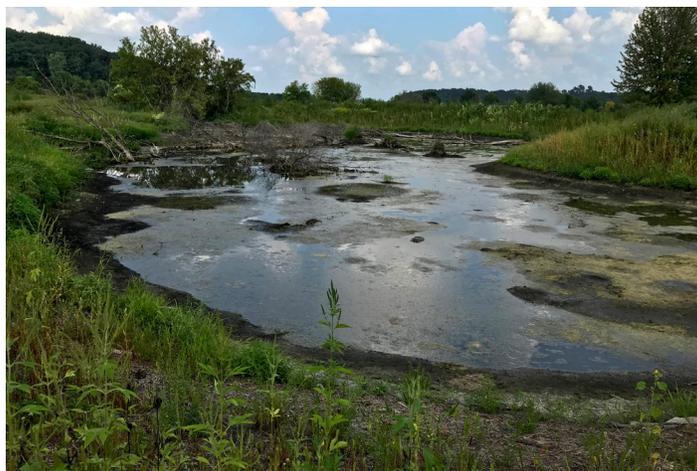
**Top:** The redesigned South Branch of Cascade Creek mimicked the sinuosity, dimension and shape of a stable channel elsewhere in the watershed. **Bottom:** Wetlands eventually will fill with water. Logs and roots will help to create habitat.

“We constructed a new channel based on the sinuosity, dimension and shape of a channel higher in the watershed that had decent stability. We took a survey on that stable area, and then we mimicked it,” Langer said.

Only the five wetland basins, built this spring in the final construction phase, still looked manmade. They will treat stormwater, trap sediment, provide flood attenuation and eventually provide wildlife habitat. Engineers hope the wetlands will distract beavers and keep them from damming the creek.

Meanwhile, Nick Proulx, a clean water specialist with the DNR, said by incorporating shallow spots and deep pools — bits of the abandoned stream — the wetlands will provide microhabitats for spawning fish, invertebrates and shorebirds. Eliminating mowed grass should discourage Canada geese.
