With conservation comes flood control

Murray County projects in the Des Moines River headwaters include easements with water-storage benefits; address pollution issues through permanent cover

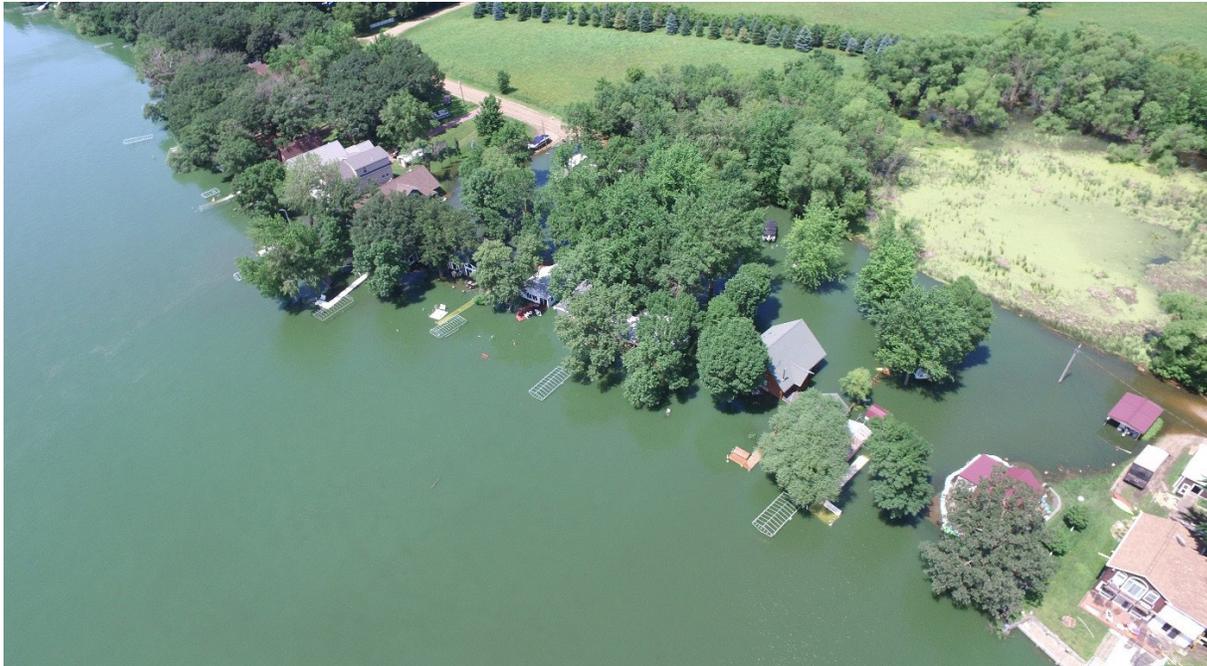
Lakeshore homes on Lake Shetek flooded in July 2018. Over the past couple of decades in Murray County, more frequent and heavier rains combined with drainage outlet failures and reduced storage capacity have contributed to more frequent flooding. **Photo Credit:** Murray County Emergency Management

The 2018 floods followed a wet spring capped by heavy rains in late June, and a torrential rain on July 3. Large parts of Murray, Lyon and Redwood counties were affected. Houses on Lake Shetek were inundated. Nearly 100 people were evacuated from Currie and the Lake Shetek area.

Flooding also caused widespread damage to roads and drainage infrastructure, and inundated property throughout much of Murray County. At Lake Shetek in particular, runoff produced heavy flows upstream. The downstream outlet was backed up by Beaver Creek, which joins the Des Moines River just below the outlet, and was running extremely high.

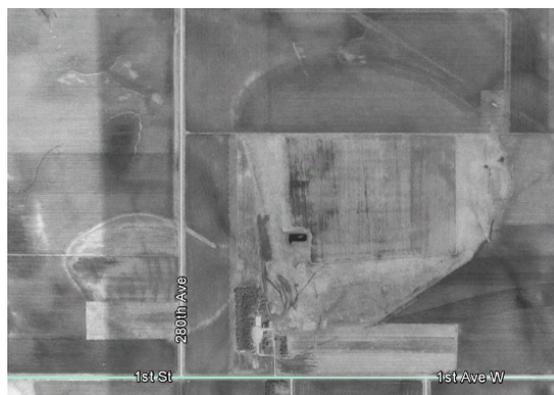
An aerial view shows the Murray County Ditch 30 restoration area when it was farmed in 1991. Seven parcels, six easements and four landowners completed the easement acquisition process in 2018. **Contributed Photo**

In the end, seven separate parcels on six different easements involving four different landowners completed the easement acquisition process that ended in 2018.

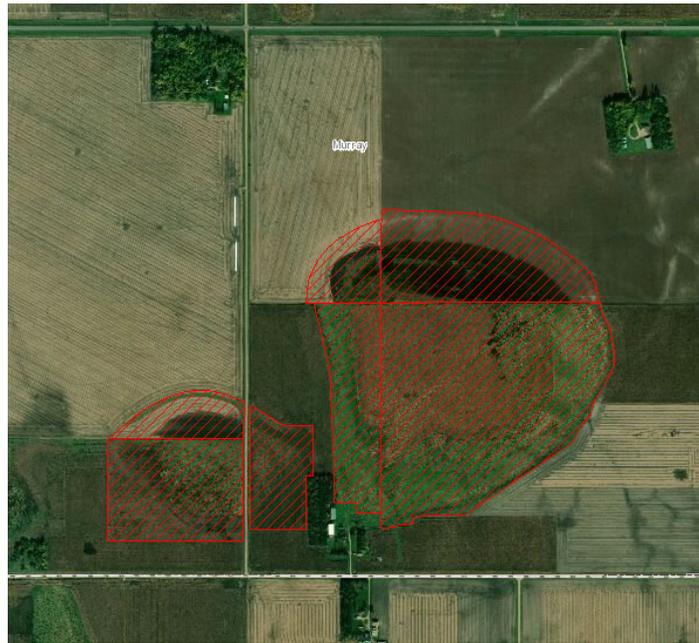
A view of the County Ditch 30 restoration area in 2015 shows seven separate parcels involved in the easement complex. Contributed Photo

When the remaining easements with three landowners were contracted during the 2015 Reinvest in Minnesota (RIM) wetland program, the footprint of the wetland was complete.

The work, estimated to cost \$140,000, will continue — outletting drainage tile lines that flowed into the wetlands from agricultural land, breaking tile within the restored area, and constructing outlets to manage restored water levels. A total 6,740 feet of 12- and 16-inch county drain tile will be abandoned.
