# Rice County erosion project aims for flood prevention

January 2015 Snapshots

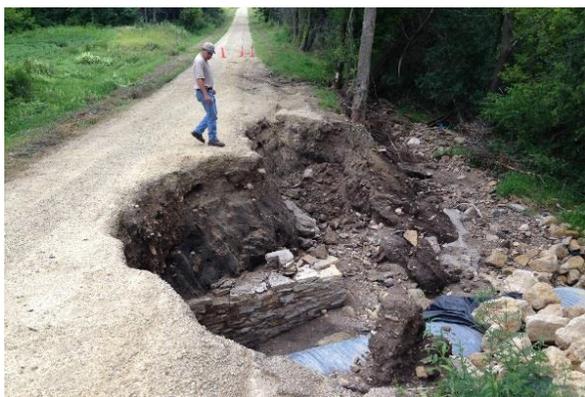
Flooding has been a problem within Rice County's Spring Creek watershed for the past several years. Heavy rains and resulting high waters have eroded gullies and washed away roads in Bridgewater Township, flooding houses all the way into Northfield, a few miles down the road. Using \$35,000 in flood relief appropriations from the Board of Water and Soil Resources, the Rice Soil and Water Conservation District (SWCD), in partnership with the Bridgewater Township, began work to address the issue.

*Pictured, top: 125<sup>th</sup> Street in Bridgewater Township was washed out after a heavy rain event. Middle: Deep gullies have formed along the edge of the property. Bottom: South end of the newly constructed grade stabilizer.*

To address the erosion and prevent future washouts to county roads, the SWCD installed a grade stabilization structure called a berm that will slow water down and allow water to drain slowly rather than all at once. The gullies along the edge of the field will be controlled, slowing their creep into crop acreage. Engineering for the project was provided by the Southeast Technical Support Joint Powers Board.

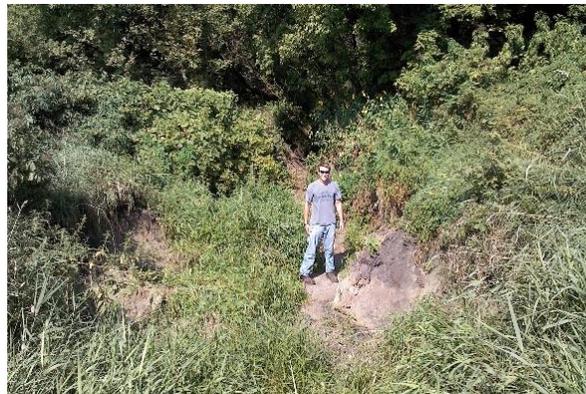
Work centered on a local farm that was already using best practices like strip-till farming to try and control erosion and runoff. These efforts weren't quite enough when heavy rains fell. Over many years, weather and high waters took a toll, forming gullies along the property. The SWCD estimates that 200 tons of soil were being lost annually from these gullies, as water ran off the farmland downstream.
