Seepage Fens add unique twist to southwestern Minnesota restoration project

May 2014 Snapshots

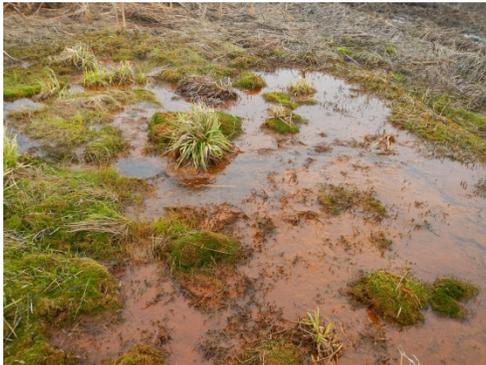
Fens are peat-forming wetlands that get water and nutrients from sources other than rainfall. The fen at the Hansen Wetland get their water from groundwater seeping out along hillsides. The fens take on fascinating features in the form of circular or oblong "domes" of peat that are anywhere from 15 - 50 feet wide and 2 – 10 feet high and can be startling to encounter. You might have dry feet at the base of the peat mound, then

wetter and wetter feet as you walk uphill towards the center, and if you're not careful you will fall in a pool at the top. This is not the usual wetland experience!

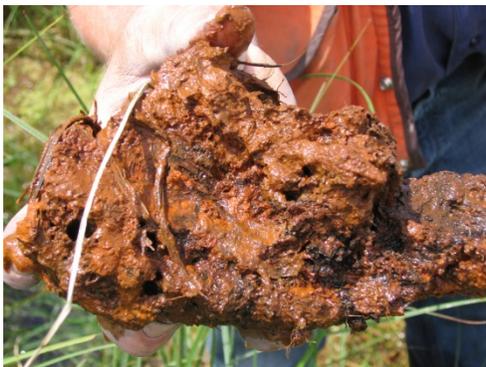
Rust-colored particles drop out of the water emerging from the fen, often forming a rock-hard crust.

The domes in the Hansen Wetland are saturated to the surface and maintain a year-round discharge of iron-rich ground water. As the water hits the atmosphere, the iron oxidizes and drops out of solution as rust-colored particles. The "rust" often forms a rock-hard crust.
