Restoring a Rustic Gem in Dakota County

April 2014 Snapshots

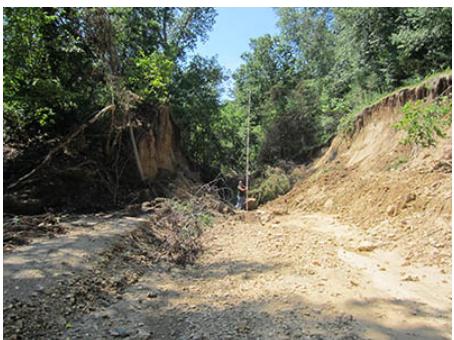
One of the major projects was an earthen dam that blew out during the heavy rainfalls, sending approximately 5,500 tons of sediment downstream and leaving unstable vertical banks behind. Constructed in the 1970s, to provide rate control for an upland watershed to the Cannon River, there was not enough funding available to replace the dam. Those banks were a safety risk in the park, though, which made repairs on the public land eligible for FEMA funding.

Top picture: the site after flood event.

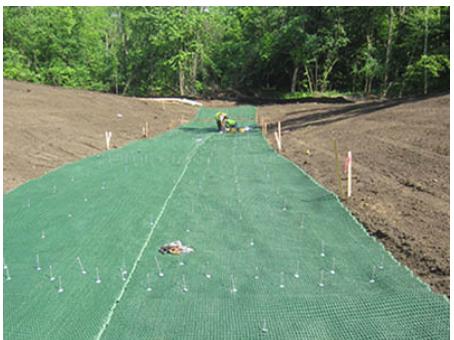
Middle picture: laying down the geotextile turf reinforcement mats.

The SWCD graded the vertical banks into gentle slopes and installed permanent geotextile turf reinforcement mats to hold soil in place, and then reestablished site vegetation using topsoil, native seed and more erosion control blankets.

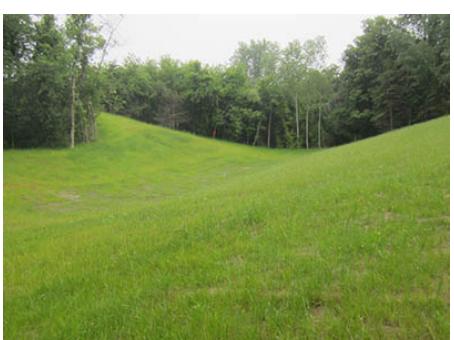
Bottom picture: the site after work was completed.

Besides restoring the site to its former beauty, this project will save 614 tons of soil and 614 pounds of phosphorus annually. "This wasn't as simple as just replacing the earthen dam," Dakota County SWCD District Manager Brian Watson said. "It was about assessing cost effective solutions and installing conservation practices to stabilize the site, and the areas downstream, from damage during future rain events."
