Designed for trout and traffic

Carlton SWCD worked with county transportation department, federal and state funds to replace a culvert with a free span bridge, restore a length of Stateline Creek to improve habitat, water quality

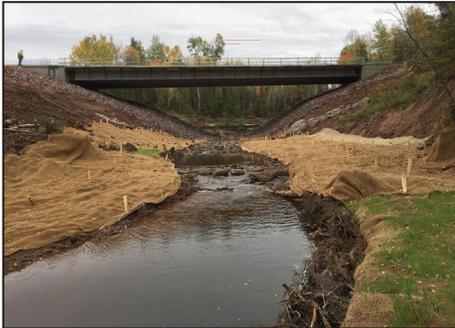
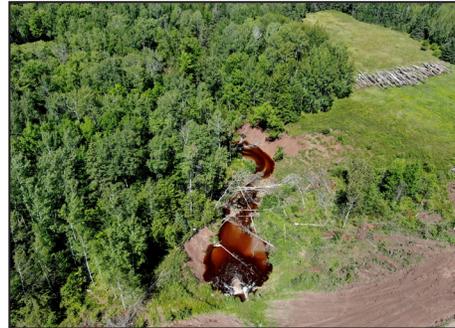
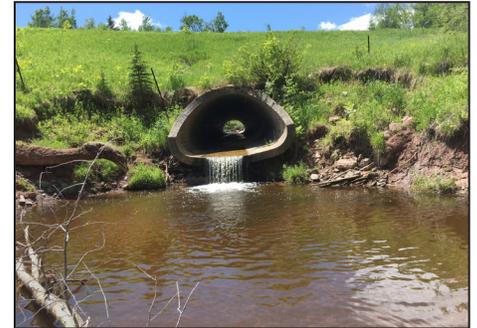
An upstream view of Stateline Creek features the free span bridge, **left**, which replaced an undersized culvert crossing on Carlton County Road 8, **right**. The bridge was part of a \$2 million project that redesigned the stream crossing to improve highway safety, fish habitat and water quality.

An aerial view of the Stateline Creek site, **center**, depicts water flowing through the culvert. The new free span bridge will allow fallen trees and other debris to more easily pass under the road.

The original 11.6-foot-wide culvert was installed in the 1970s when design was based on preventing water from topping the road in a 100-year flood event (meaning it has a 1% chance of occurring in any given year). While safe and cost-effective, it forced the stream through a narrow opening and caused a fire-hose effect — destabilizing the downstream channel, eroding the banks, and restricting fish passage. Eventually, a 2-foot drop developed from the culvert to the stream.

A culvert inventory, funded in part by a 2017 Enbridge Ecofootprint grant, identified the Stateline Creek site as a priority. A June 2018 flood that damaged the culvert prompted a discussion between Carlton SWCD and Carlton County Transportation Department staff. With input from University of Minnesota Duluth students in a graduate-level civil engineering stream crossing design class, a free span bridge was deemed the best option. The other choice was a larger culvert.

The bridge allows downed trees to pass underneath. A culvert might last longer, but Bomier said its pieces would be more likely to shift in the red clay soil. The floodplain will handle the overflow that previously caused erosion.

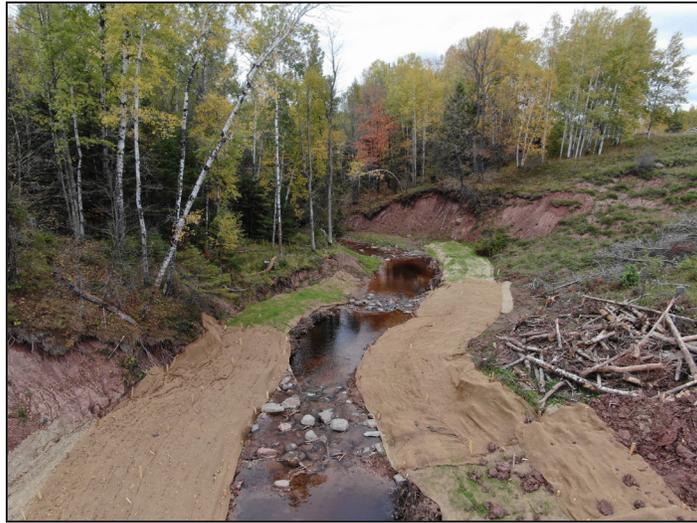
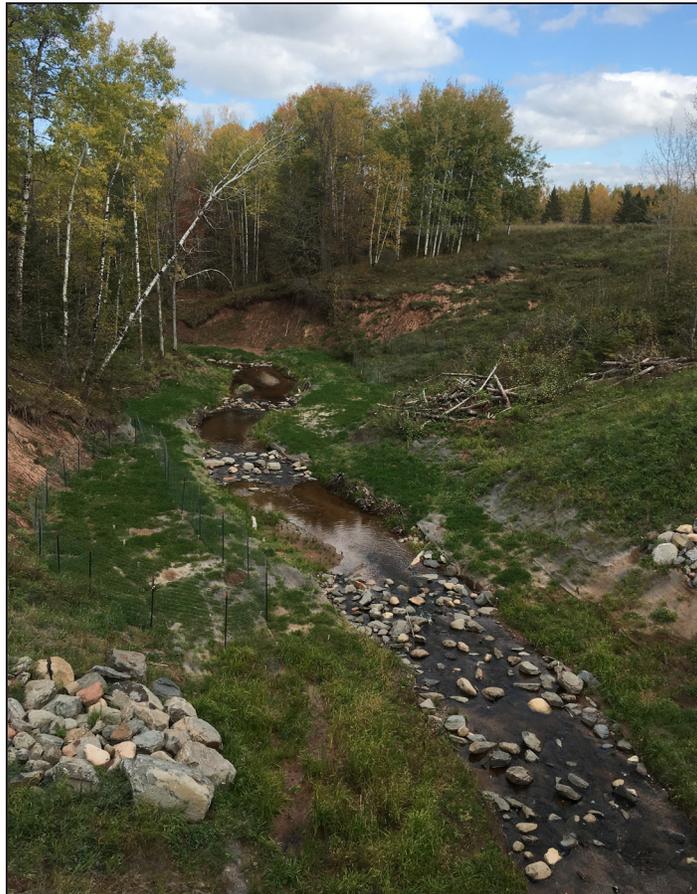
Top: A stream restoration on a 500-foot length of Stateline Creek used natural channel design methods to narrow and stabilize the channel, and to re-establish connection to the natural floodplain. A series of constructed riffle pools allow fish passage. The project also addressed streambank erosion. **Bottom:** This post-construction view of Stateline Creek was captured in 2021. **Photo Credits:** Carlton SWCD

A 500-foot-long stream restoration employed natural channel design methods to narrow and stabilize the channel, and to re-establish the stream’s connection to its floodplain. A series of constructed riffle pools act as stair steps, allowing fish passage. Root and log structures anchored to downstream banks are designed to

The project reduces soil loss by an estimated 156 tons and phosphorus by an estimated 179 pounds annually. It reconnects 8 miles of stream, allowing aquatic organisms to migrate.
