BWSR engineering tour offers insights to help overcome design challenges

The Minnesota Board of Water and Soil Resources' (BWSR) 2024 spring engineering tour showcased engineering projects throughout southwestern Minnesota. Tour attendees, which consisted of BWSR engineering staff, visited 14 sites, all of which featured projects that provide enhanced water quality, wildlife habitat and water storage. At some stops, soil and water conservation district staff, watershed district staff and landowners joined them to discuss project details.

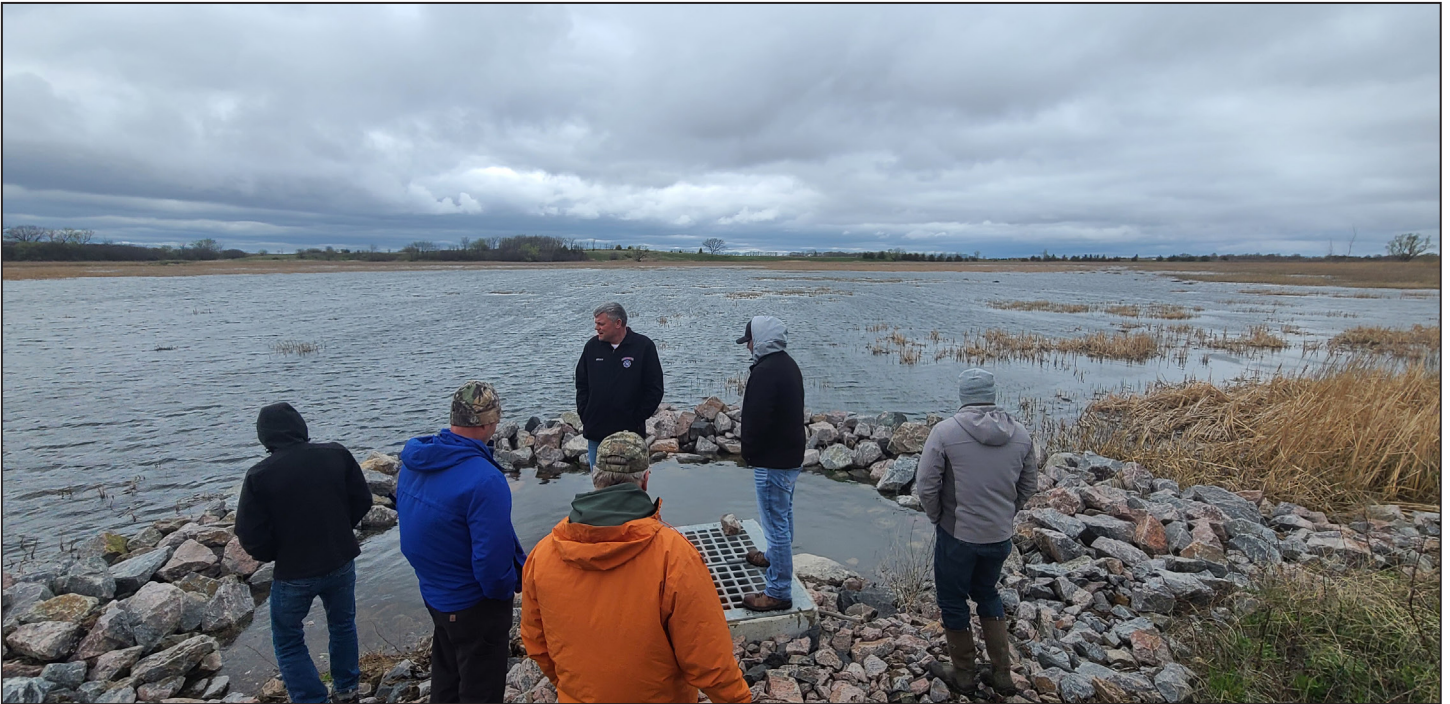
BWSR senior engineering technician Scott Santjer (in front center) and BWSR senior water resources engineer Tom Wenzel (left of Santjer) presented at the Horseshoe Lake site in Redwood County and discussed the site’s long history of maintenance issues and the recent repairs that have been done to address those issues. In an effort to prevent future clogging, a ring of large diameter rock riprap was constructed in front of the intake structure.

A stop at the Horseshoe Lake project in Redwood County offered an example of a project where engineers had to implement a design technique that deviates from BWSR's traditional approach. This wetland restoration

project was completed in 1989 and since then there has been a regularly occurring issue of wetland vegetation plugging the outlet structure, which is a water level control structure housed in a concrete box. Since the primary outlet releases wetland waters to a subsurface drainage tile system, once the intake structure clogs, the wetland pool tends to rise, causing flood impacts on adjacent properties.

"We have certain techniques to stop vegetation from clogging the outlet, but the lake's size and the types of vegetation that grew there resulted in the outlet continuing to be choked. So, staff modified our design and put rock farther away from the outlet, to function somewhat like a berm that allowed water, but not vegetation, to pass through," Weaver said.

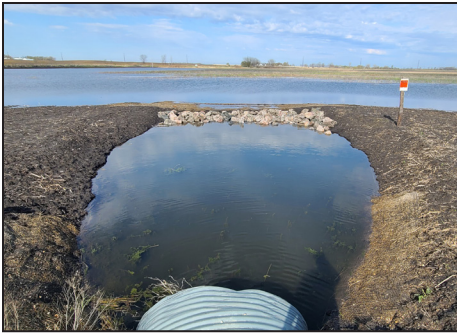
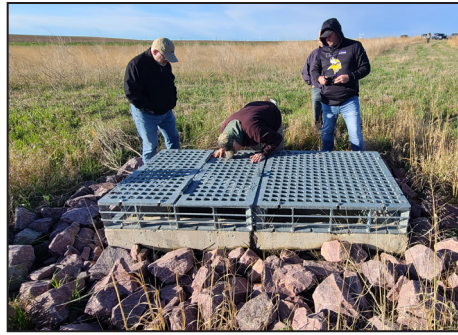
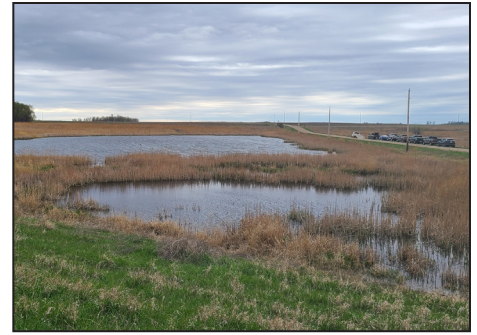
Left: Tour attendees viewed a recently constructed MN CREP project, which restored a 106-acre floodplain wetland that connects to Three-Mile Creek in Lyon County. They discussed restoration processes and how to address the site's existing drainage systems. **Middle:** Attendees checked out an outlet in Nobles County, while they discussed the restoration of this large shallow lakebed and what factors influenced the type of structure used for the outlet. **Right:** On the final tour day, attendees visited a RIM and MN CREP project in Murray County that restored two large wetlands that were previously being drained by Murray County Ditch 30 drainage system. The group discussed design challenges and necessary coordination with road authority and public drainage authority staff.
