Water quality, fish habitat shape Clearwater River streambank work

YOUR Clean Water
Fund AT WORK

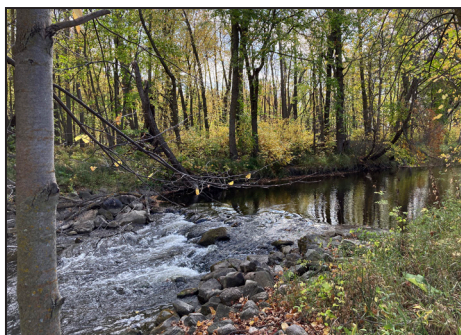
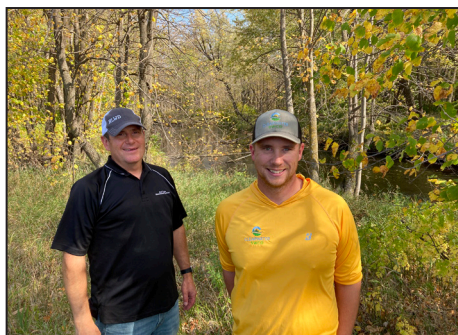
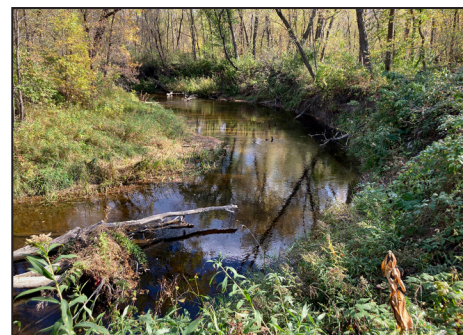
From left: Rock riffles were installed in 2004 where the naturally meandering stream meets the 35-mile-long reach dredged and straightened in the 1950s for drainage. In October 2025, Corey Hanson, Red Lake Watershed District water quality coordinator, left, and Chester Powell, Clearwater SWCD water plan coordinator and program technician, visited the site of a planned streambank stabilization on the Clearwater River. Downstream from the rock riffles installed in 2004, the banks are eroding and the flows are dangerously fast. **Photo Credits:** Ann Wessel, BWSR

The most recent fix in 2004 installed rock riffles to tame the velocity and reduce erosion. It stabilized the banks, and restored floodplain wetlands within highly erodible peat soils.

Ten years after the project was installed, a routine streambank assessment showed exacerbated erosion, unstable banks and dangerously fast flows. Geomorphology data showed an abrupt change in stream stability downstream from the grade-stabilization structures. The vertical drops had moved farther upstream. They were steeper, and no longer met the Minnesota Department of Natural Resources (DNR) standards for fish passage.
