# Water quality, fish habitat shape Clearwater River streambank work

**YOUR Clean Water  
Fund AT WORK**

**CLEARBROOK** — A mile-long streambank stabilization on the Clearwater River is designed to restore fish passage and habitat, and improve water quality in the 35-mile-long upstream stretch impaired for nutrients, E. coli and sulfates.

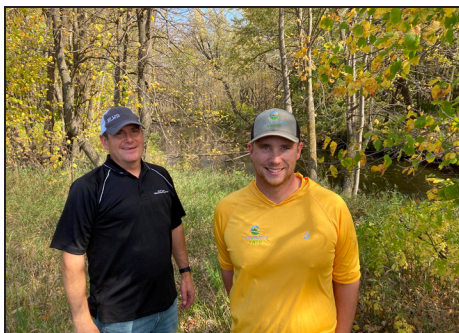
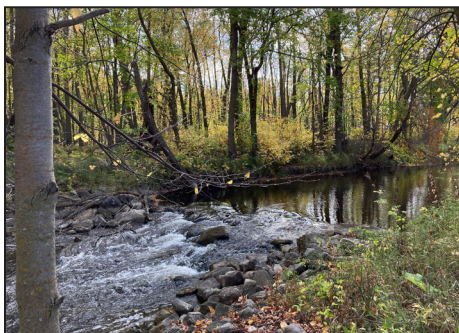
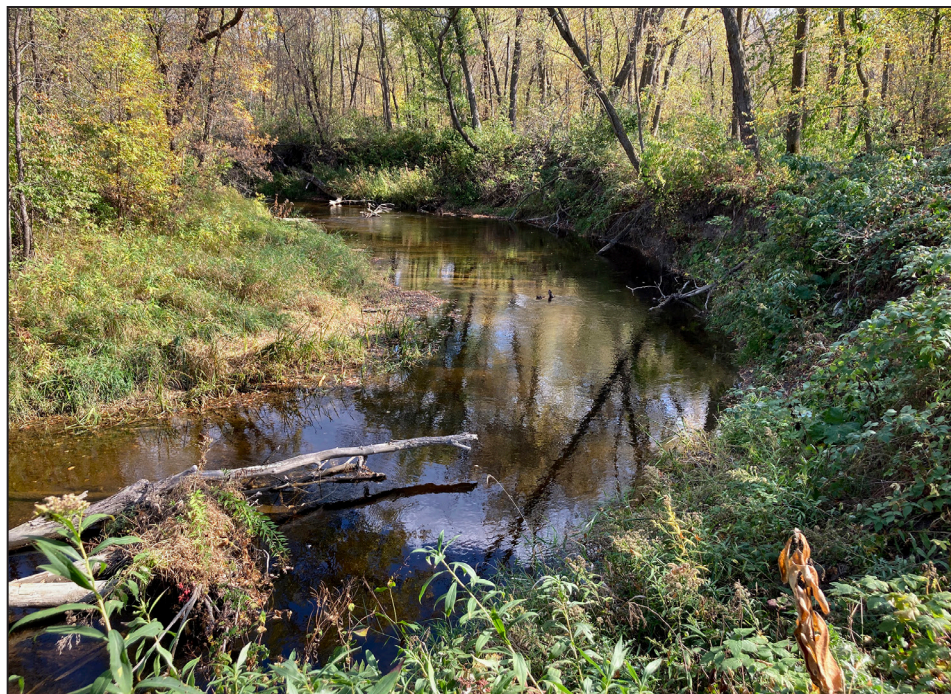
**Clockwise from top left:** In October 2025, Corey Hanson, Red Lake Watershed District water quality coordinator, left, and Chester Powell, Clearwater SWCD water plan coordinator and program technician, visited the site of a planned streambank stabilization on the Clearwater River. Downstream from the rock riffles installed in 2004, the banks are eroding and the flows are dangerously fast. Rock riffles were installed in 2004 where the naturally meandering stream meets the 35-mile-long reach dredged and straightened in the 1950s for drainage. **Photo Credits:** Ann Wessel, BWSR
