# Fish species signal potential for delisting Sand Hill River stretch

## **F**ERTILE — The return of redhorse species to a stretch of the Sand Hill River in Polk County reflects improving trends that could lead to removal from the state’s impaired waters list as early as 2026.

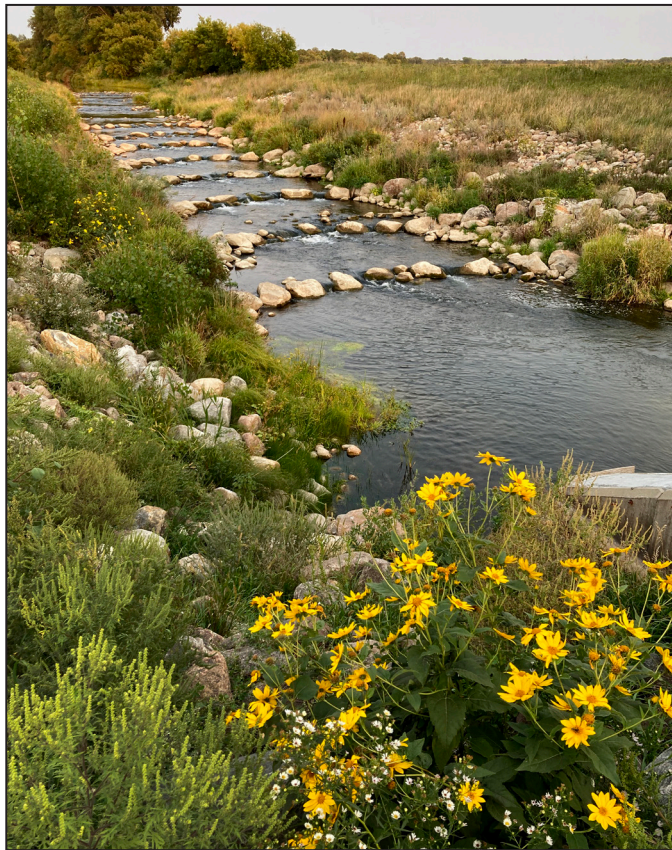
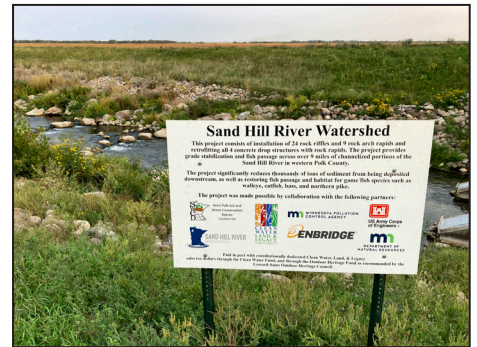
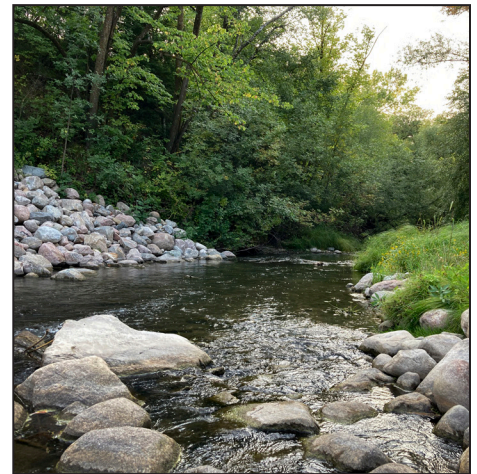
**Clockwise from left:** Clean Water Funds from BWSR supported a project on the Sand Hill River east of Beltrami that stabilized head-cutting and allowed fish passage across channelized segments of the river. A sign names partners. An Outdoor Heritage Fund-backed Sand Hill River Watershed District project removed the Poissant Bridge and abutments in 2021, and installed rock arch rapids to restore floodplain connectivity.  
**Photo Credits:** Ann Wessel, BWSR

Fertile is at the midpoint of the 32-mile-long downstream segment showing improvement. Removing the IBI impairment could be proposed for all or part of that segment, where 2011 monitoring turned up no large fish species. Since then, 25 rock riffles and four rock arch rapids have replaced four dams west of Fertile on the Sand Hill River, a Red River tributary.

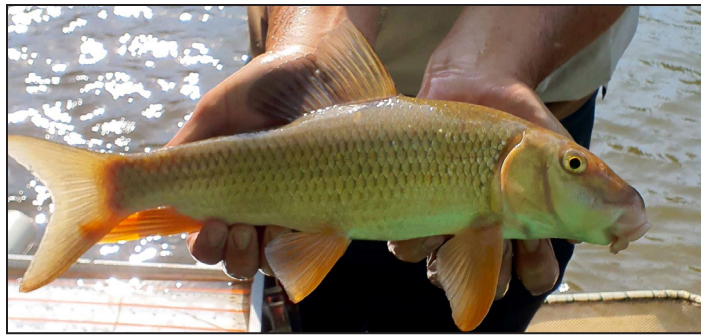
Silver redhorse are among the species returning to the Sand Hill River near Fertile. This one was caught while sampling another river. Photo Credit: MPCA

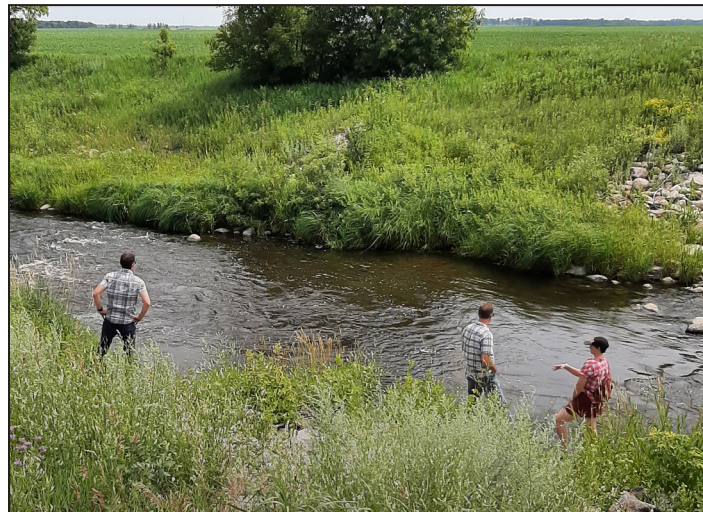
**Top:** The sun set over the Sand Hill River east of Beltrami. The 495-square-mile Sand Hill River watershed is among the 10 major watersheds in the Red River Basin. **Photo Credit:** Ann Wessel, BWSR **Above:** BWSR staff members on July 13, 2023, visited a stretch of the Sand Hill River in Polk County during a tour of implemented projects. A Clean Water Fund grant from BWSR supported the rock riffle project on the Sand Hill River. **Photo Credit:** BWSR

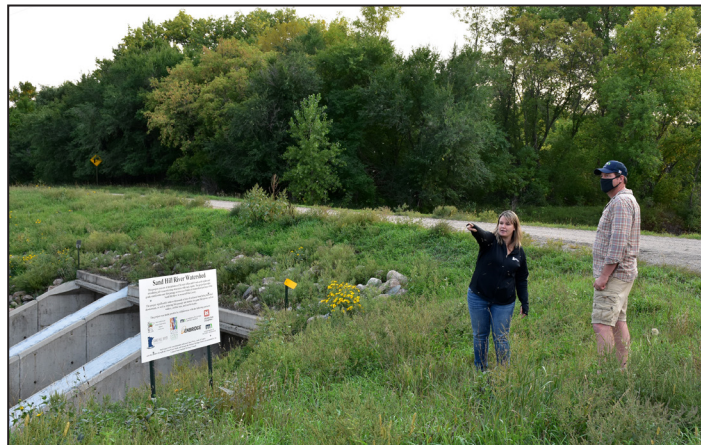
*Sand Hill River Watershed District Administrator April Swenby showed BWSR Board Conservationist Darren Mayers elements of the rock riffles and rock arches project in September 2021 on a stretch of the river east of Beltrami. Photo Credit: Ann Wessel, BWSR*
