Culvert inventory aids road safety, trout

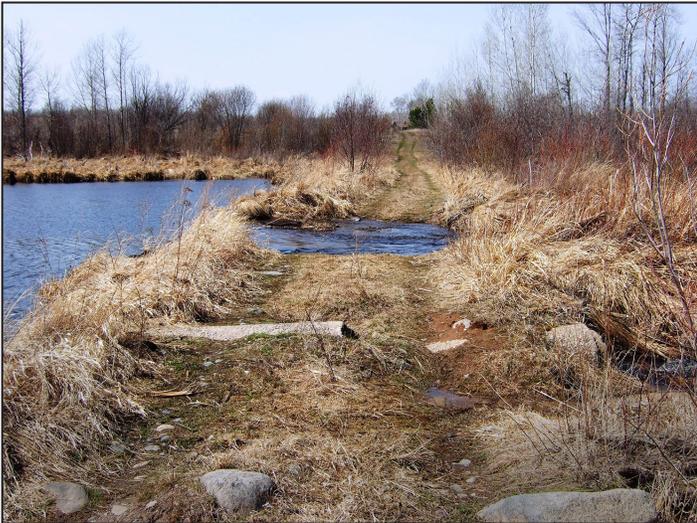
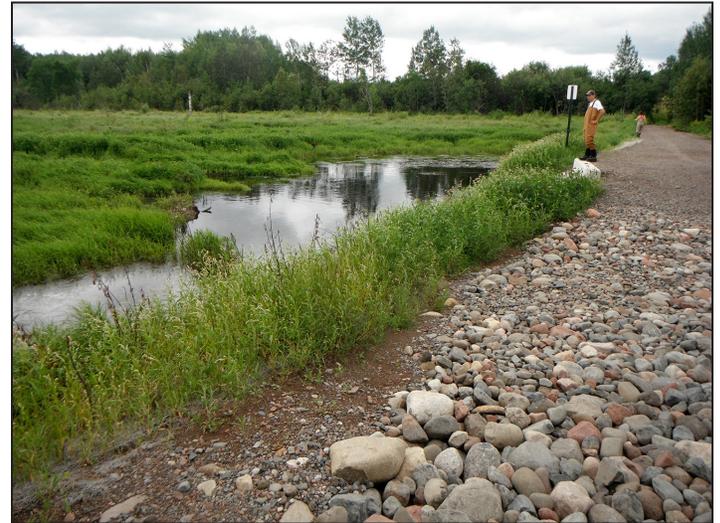
Before-and-after views of a failed culvert and collapsed road spanning Martin Branch, a trout stream that empties into Stoney Brook, illustrate the problem and solution. The culvert was removed and fixed in 2011, and held up well in the 2012 flood. The Fond du Lac Band of Lake Superior Chippewa has since seen the flooded wetland recover and the stream-dwelling macroinvertebrate population improve. **Photo Credits:** Fond du Lac Office of Water Protection

“The biggest disaster is during very, very high flows you can wash out enough material in and around the culvert that the road fails and the culvert washes away. That’s catastrophic failure,” Andrews said.

“Over time, especially if (culverts) are under-sized, the water — as it’s swirling around waiting to get in the culvert, and then as it comes out of the culvert at high speed — will erode the stream,” Andrews said.

Even culverts installed flush with the stream level can become perched, resulting in a 6- to 12-inch drop from pipe to pool.

Now, replacement culverts match the width of the stream. They’re set 1 to 2 feet deeper to compensate for erosion. Substrate is designed to mimic the streambed.

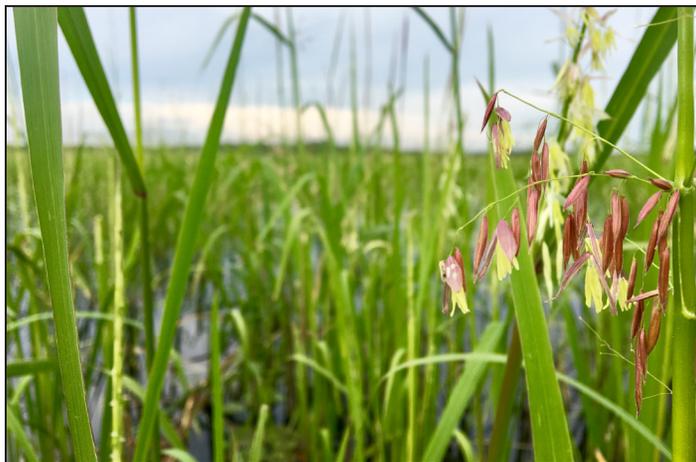
Culverts play a role in regulating water levels for wild rice production.

Because the topography is flat, Hedin said a small change in culvert size can have a big effect on road crossings and wild rice habitat. The grain is susceptible to fluctuations in water level.
