# A flood, a phone call, a wave of relief

In Lyon County, the conservation work Area II Minnesota River Basin Projects accomplished with one landowner is put to the test

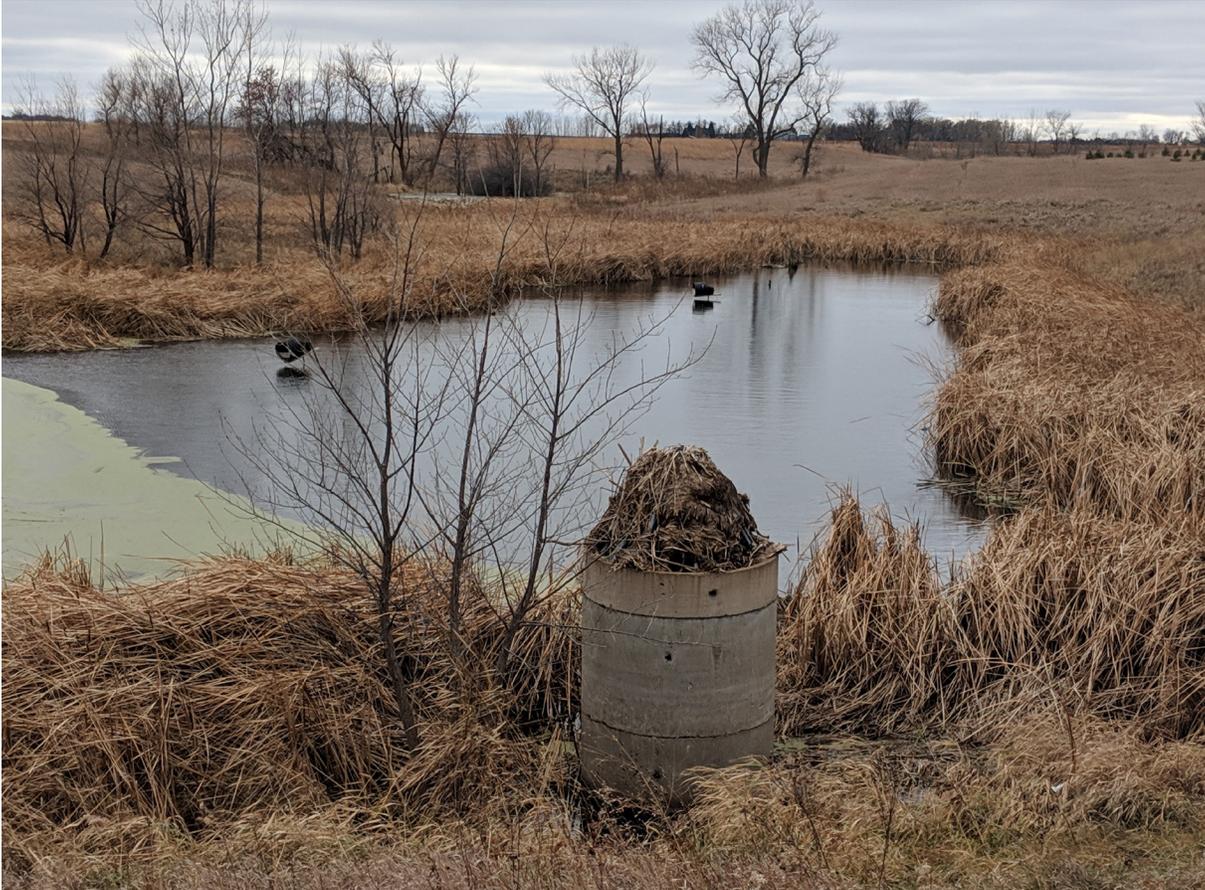
*Greg Taylor had installed a series of 12 dams on his Lyon County property. After two hard rains, the retention ponds filled but didn’t overflow into the emergency spillway. Three to 4 feet of debris covered the grates in the ponds’ concrete overflow structures. Taylor took care of the post-storm inspection and debris removal.*

Three to 4 feet of debris covered the grates in the ponds’ concrete overflow structures. Trash racks are installed at the top of the concrete manhole risers to prevent floating debris from entering and clogging the concrete pipe that runs through the earthen embankments. The conical-shaped galvanized steel rack is designed for debris to clear itself when floodwaters recede. With so much debris collected, in this case it was necessary to manually clear the accumulated cornstalks and small tree limbs.

The landowner is responsible for post-storm inspection and debris removal; it’s part of the operation and maintenance agreement that accompanies this type of project.
