Restored river channel improves safety

Warroad River Watershed District's first major undertaking taps Clean Water Fund, disaster relief grants; sediment reduction expected in Roseau County waters downstream

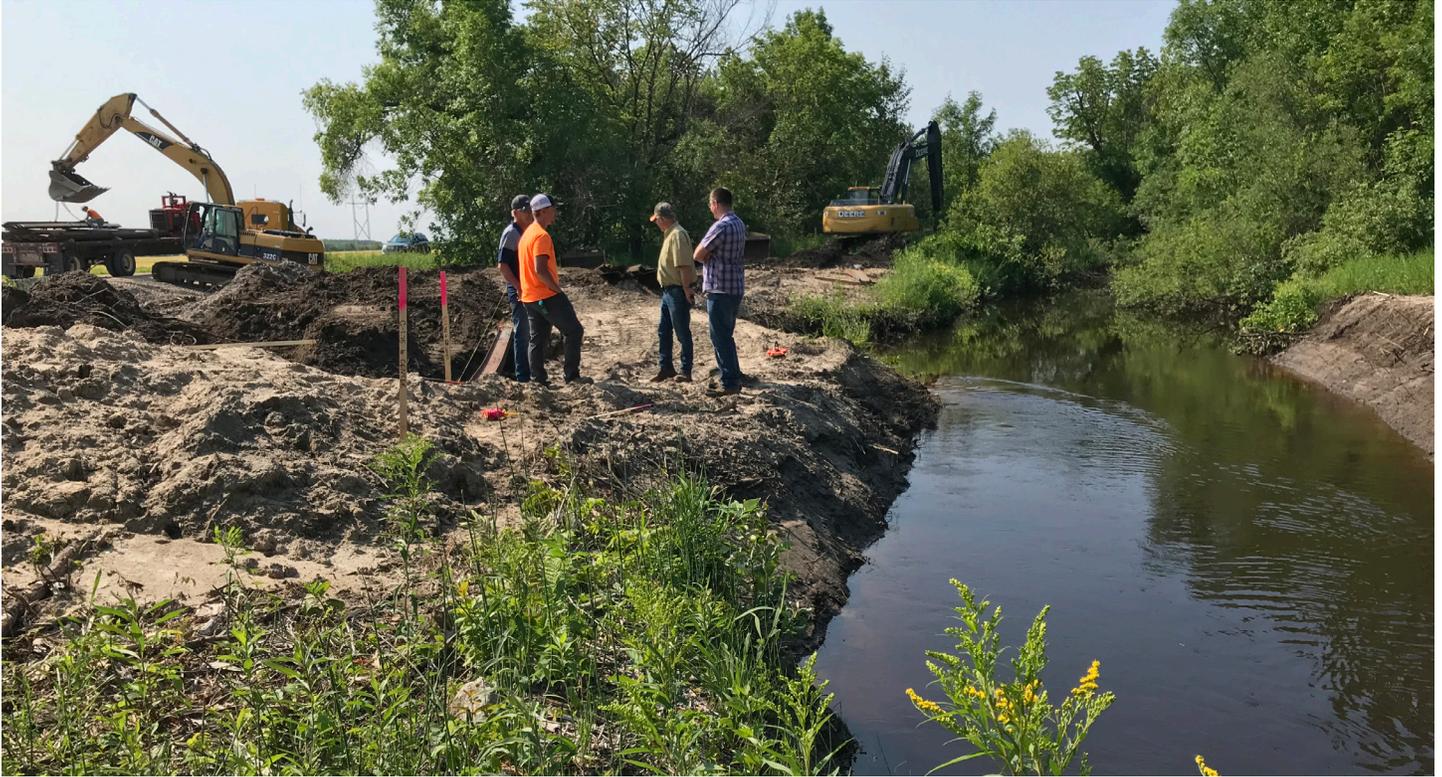
In late July, heavy equipment drove sheet piling into the ground — part of a 50-foot-long, riprap-armored water control structure — while WRWD Board President Bill Thompson and

Treasurer Keith Landin monitored progress at the site. A dam separated the restored channel from the ditch. Ferns flourished along the restored riverbank.

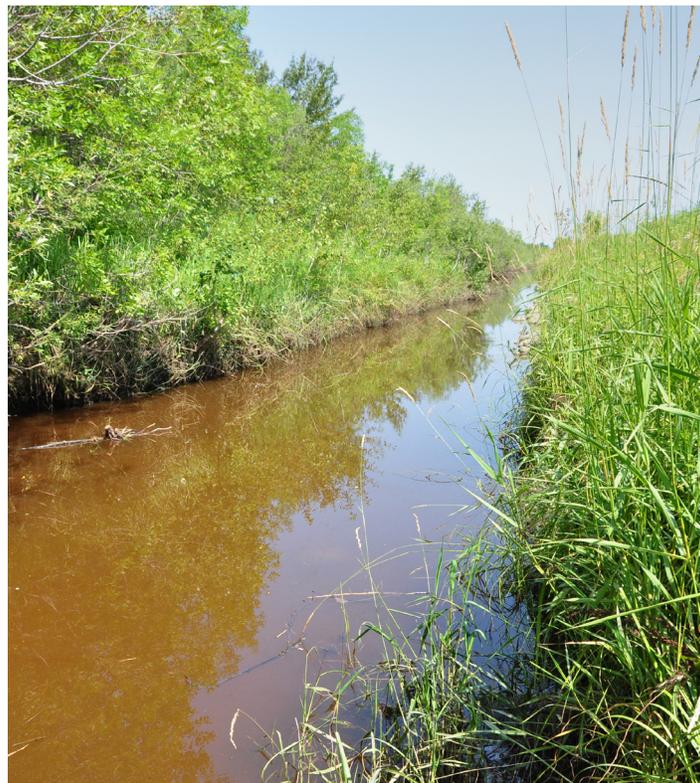
A previously straightened stretch of the West Branch Warroad River flowed down a township road ditch. The gravel road was prone to erosion.

Since the 1970s when a landowner diverted the West Branch into the ditch, the river had repeatedly eroded the gravel road. The steep ditch was especially dangerous during flood conditions.

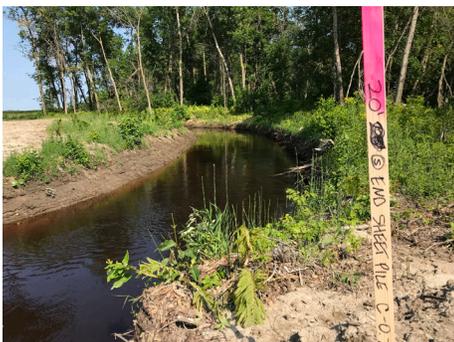
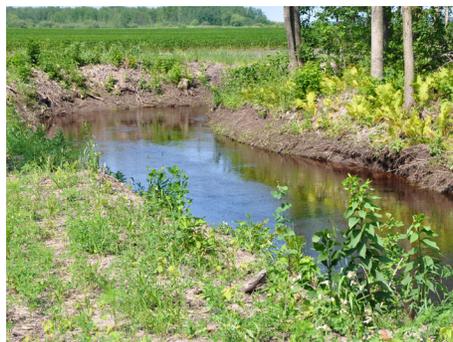
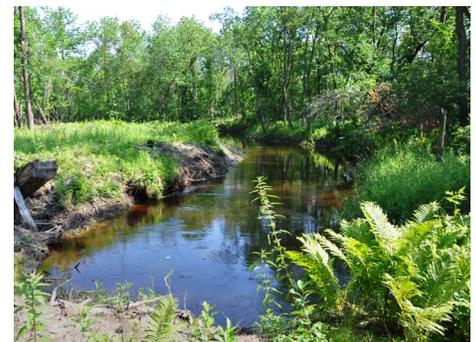
Left: A Warroad River Watershed District project that returned a stretch of the West Branch Warroad River to its natural, sinuous streambank was nearly complete in late July. **Center:** The structure held up to severe flooding in September. Some spots that eroded at the field's edge, seen here in July, will be fortified. **Right:** Returning a segment of the West Branch Warroad River to its natural channel more than doubled its length to about 10,750 feet. The natural twists and turns cut velocity and reduce erosion.

The weir is designed to contain water within the river channel except during high flows. During high flows, the floodwater is meant to spill over the top; the ditch is meant to handle that overflow.

The structure held up to September's severe flooding, but water spilled around the edges and into the seeded area. Landin said that part of the weir will be raised. Some spots eroded at the field's edge; those will be fortified.

Returning the stream segment to its natural, meandering channel more than doubled its length — from a 4,300-foot straightened state to about 10,750 feet of twists and turns that cut velocity and reduce erosion.
