Coon Creek Watershed District links habitat, stormwater work

C OON RAPIDS — On a stream that carries stormwater runoff from a densely populated suburb, the Coon Creek Watershed District overcame constraints of its urban setting to improve habitat, reduce the likelihood of flash flooding, and curb pollution bound for the Mississippi River.

The two-phase, \$1.3 million Sand Creek restoration project leveraged \$577,930 in Clean Water Funds from the Minnesota Board of Water and Soil Resources, and \$560,540 in U.S. Environmental Protection Agency funding through Section 319 of the Clean Water Act. Work focused on a 1.2-mile-long stretch.

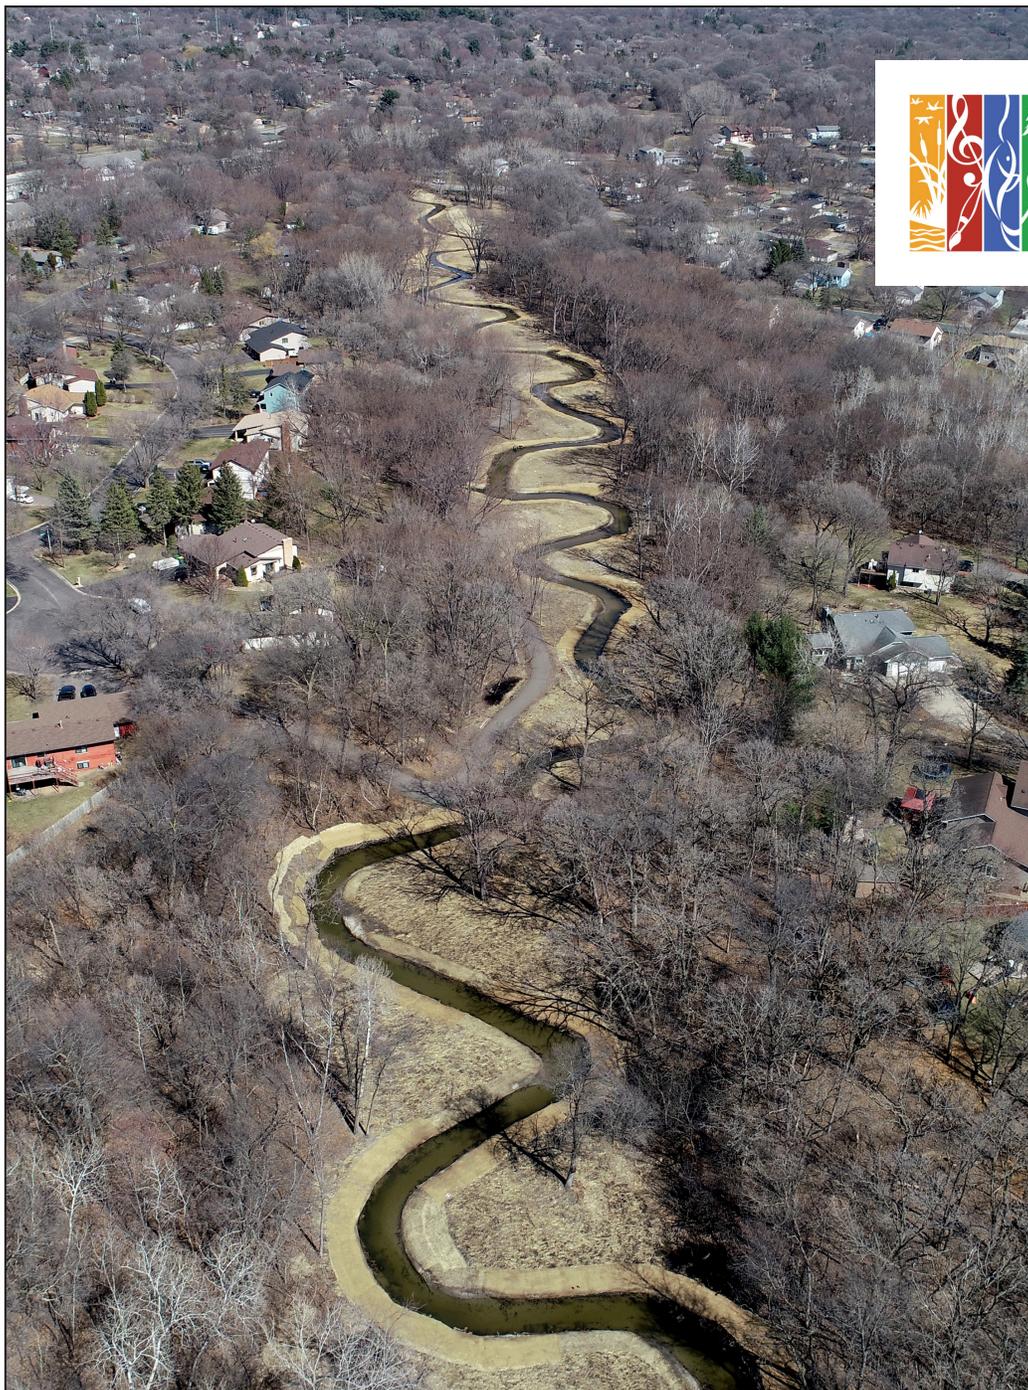
An aerial view of Middle Sand Creek, photographed on April 1, 2021, looking upstream from the BNSF Railway stream crossing, depicts the length of the meandering in Coon Rapids. Two Clean Water Fund grants from BWSR — \$195,160 awarded in 2018 for Lower Sand Creek corridor restoration, and \$382,770, awarded in 2019 for Middle Sand Creek corridor restoration — supported the work, which will curb sediment-loading by an estimated 468 tons a year. **Photo courtesy of Coon Creek Watershed District**

That two-thirds-mile-long segment used natural channel design methods to return the straightened stream to its winding course, adding 625 feet of length via curves that slow the velocity. The design created a 50-foot-wide floodplain, and lowered the floodplain level by as much as 2 feet.

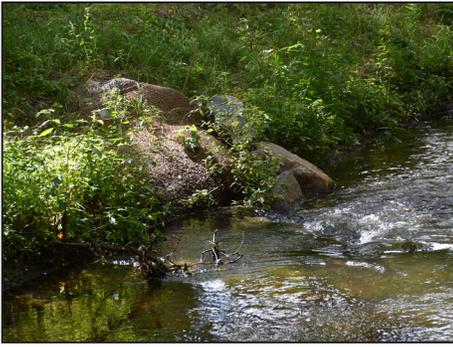
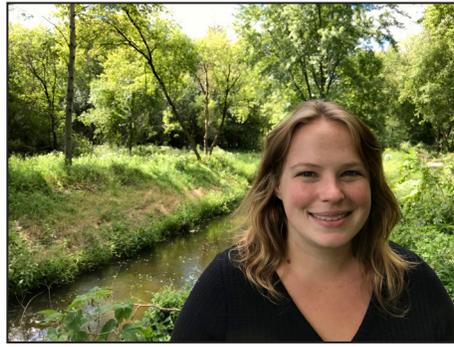
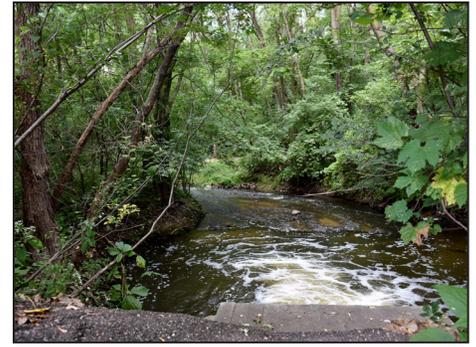
Left: The first stage of the CCWD’s Clean Water Fund-supported work on Sand Creek in Coon Rapids focused on Lower Sand Creek corridor restoration. Construction included five backwater pools, and six rock cross vanes designed to control the grade and direct stream flow to the center of the channel. The project incorporated three streambank stabilization techniques: toe wood protection, resloping, and vegetated rock riprap. **Middle:** CCWD Water Quality Coordinator Justine Dauphinais walked along a stretch of Sand Creek in fall 2019. **Right:** Most of Sand Creek functions as a ditch; only the downstream 2.2 miles function as a stream. A segment of the downstream portion is seen here in September 2019 at a crossing in Coon Rapids. **Photo Credits:** Ann Wessel, BWSR

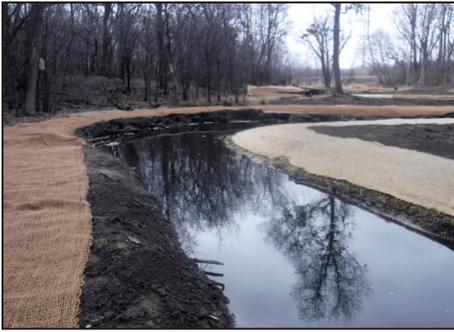
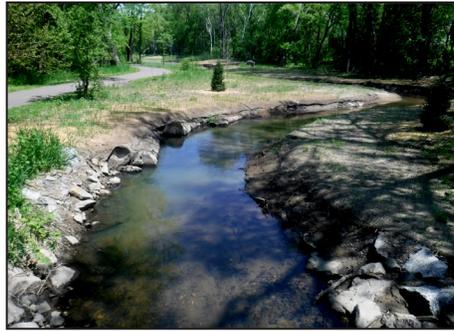
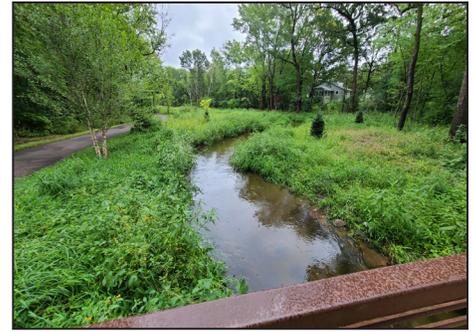
Left: Streambanks of the newly meandered segment of Middle Sand Creek, seen looking downstream from the pedestrian bridge at Sycamore Circle Northwest, between the BNSF Railway tracks and Olive Street in Coon Rapids, were seeded with native species and stabilized with straw and coir erosion control blankets. **Middle:** The spring after construction on a segment of Middle Sand Creek was complete, water flowed in the constructed, meandering channel. A few planted trees were visible along the banks, which were seeded with native species. This upstream view is from the pedestrian bridge at Sycamore Circle Northwest, between the BNSF Railway tracks and Olive Street in Coon Rapids. The view from the same spot that summer, **right,** shows the growth of native plants. **Photos courtesy of Coon Creek Watershed District**
